USAFOEHL REPORT = 88-146EQ00:1LEF

WASTEWATER CHARACTERIZATION SURVEY, BARKSDALE AFB, LA

November 1988

Final Report

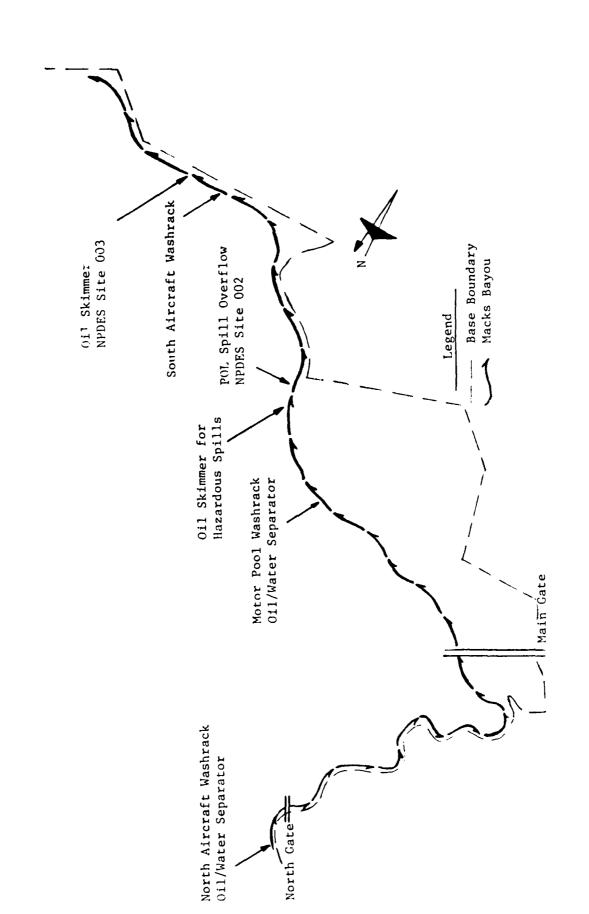
Figure 1. Various Outfalls Into Macks Bayou

- A. Survey Procedures
 - 1. Wastewater Characterization Survey
- a. Macks Bayou Reconnaissance Macks Bayou was walked from its origin near the North Gate to a point past the skimmer/oil separator designated by proposed discharge permit LA0007293 as site 003 to determine the various outfalls into the bayou. A sketch of the discharges into the bayou is included as Figure 1.

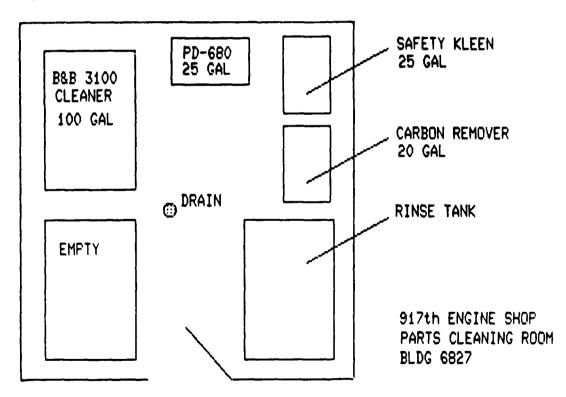
Figure 6. Parts Cleaning Room, 917th Engine Shop

Engine Shop personnel are responsible for the buildup and repair of TF-34 engines and auxiliary power plants. Waste aircraft soap (50 gallons/month, diluted 10:1) and PD-680 (25 gallons/month) are used for cleaning equipment and floors. Cleaning wastes are drained directly to the sanitary sewer via an oil/water separator. Waste 7808 and 1010 engine oils (30 gallons/month), fuels (5 gallons/month) and wastes from the parts cleaning room (see Figure 6) are drummed separately. These wastes are placed at a secured accumulation site, located in front of the facility, for eventual disposal by DRMO. Waste hydraulic fluid (1 gallon/month) is sent to the Aerospace Ground Equipment (AGE) accumulation site, building 6447. The shop also has a 30 gallon Safety Kleen degreasing unit that is changed out by contractor every 3 months.

- Site 5. A TTO concentration of 11.2 mg/l (2.7 mg/l of 1,1,1-trichloroethane and 8.5 mg/l of 1,3-dichlorobenzene) exceeded the pretreatment standard of 2.13 mg/l in the 917th Engine Shop separator. The TTO results indicate the release of degreasing solvents to the sanitary sewer. This shop needs a pretreatment process if the rinsewater cannot be collected as a hazardous waste. Pretreatment, in the form of air stripping or powdered activated charcoal (PAC) adsorption could be performed at a central location on wastes from this shop and Corrosion Control Shop. A low pH of 5.0 combined with a conductivity of 4000 µmhos suggests the discharge of an acidic waste to the sanitary sewer.

- Site 17. The Corrosion Control Shop is exceeding the pretreatment limits for TTO, chromium and zinc. The 917th Engine Shop is exceeding the pretreat- ment limits for TTO. A pretreatment system should be installed servicing both shops to remove the waste prior to entering the sanitary sewer.
- Site 17. Dragout from a 300 gallon stripping vat located outside the Corrosion Control Shop should be controlled. The tank should be moved inside where spills can be prevented from entering the environment.
